ANALYSIS AND SIMULATION OPTIMIZATION OF CONNECTING ROD CAP FAILURE IN COMPRESSOR

Key Words: Connecting Rod Cap, Failure, Physical and Chemical Analysis, Simulation Optimization

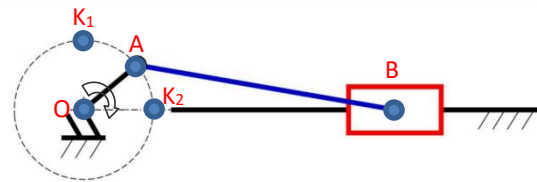
Figure 2: Simplified structure diagram.

The main working principle of reciprocating compressors is that the motor drives the crankshaft to rotate, and the piston is driven to move back and forth periodically in the cylinder wall through the connecting rod. The entire ideal working cycle is divided into three parts: intake, compression and exhaust. During these three stages, in the compression stage, as the piston changes direction under the drive of the crankshaft, that is, when point A moves from k_1 to k_2 , the piston moves to the right and the intake valve closes. The volume of the working space decreases, and the pressure inside the cylinder continuously rises until it reaches the rated pressure. According to Newton's third law, the force is mutual, so the load on the connecting rod cover at this time should be the largest and is the most likely to fail. Therefore, when conducting finite element analysis, the compression stage is taken as the sample, and the constraint conditions of the connecting rod cover are established, and the driving conditions are applied. At this time, the piston, connecting rod, crankshaft and connecting rod cover are on the same straight line, and these components are simplified into one rigid body. The load of the compressed air will directly act on the connecting rod cover. At this time, there should be tensile force acting on the four connecting bolts between the connecting rod cover and the connecting rod. The simplified model is shown later in Fig. 15.

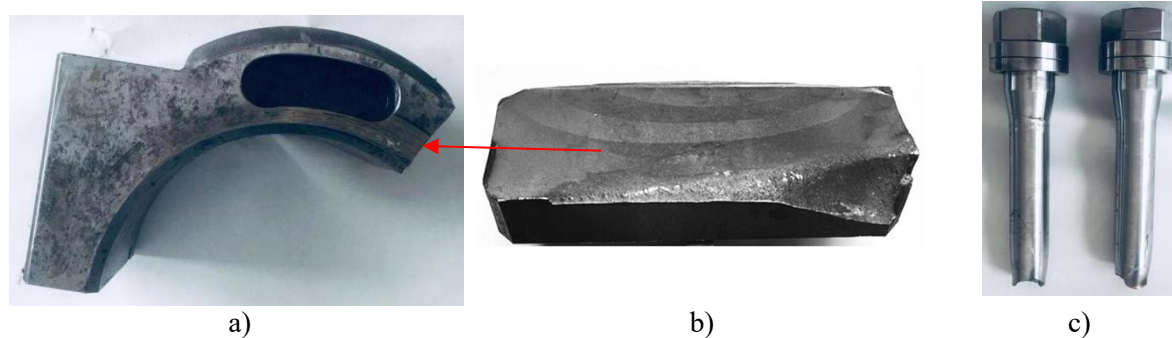
Figure 3: The state of fracture.

The fracture location of the connecting rod cap is at the transition R position of the connecting rod screw installation surface, where there is a significant stress concentration

feature. The fracture surface shows typical fatigue expansion arc patterns (fatigue striations), and the crack source area is located on the transition R surface area. The fatigue crack radiates outward and eventually leads to instantaneous fracture. The specific morphological features are shown in Figs. 3 a and b. Both of the two fractured connecting rod screws have significant necking near the fracture surface, and obvious plastic deformation marks can be seen at the root of the thread. The fracture surface presents a dimple morphology, which conforms to the macroscopic characteristics of single overload fracture, indicating that the connecting rod screw experienced a one-time ductile fracture under tensile stress. The fracture morphology is detailed in Fig. 3 c.

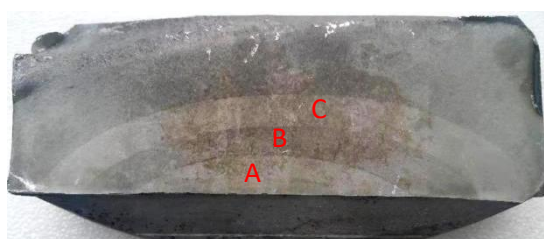
Figure 4: Schematic diagram of fracture zone partitioning.

Through scanning electron microscopy analysis of the fracture surface, the results show that area A is clearly identified as the fatigue origin zone of the fracture surface. The fatigue source area presents a clear linear fatigue source morphology, which strongly indicates that stress concentration is the main driving factor for fatigue origin, belonging to the typical fatigue origin characteristics dominated by stress concentration. Relevant images can be seen in Figs. 4 to 6. Further examination reveals that no slag inclusions, voids or other metallurgical defects are observed on the fracture surface, indicating good metallurgical quality of the material. Area B is defined as the fatigue propagation zone, and the fatigue propagation striation features can be clearly observed in the microstructure, which present regular spacing and direction, reflecting the typical process of periodic crack propagation. Specific details are shown in Figs. 7 to 8. Area C also belongs to the fatigue propagation zone, and the fatigue propagation striation features are clearly visible in the microstructure, which are consistent with those in area B, showing stable crack propagation behaviour. Relevant images are shown in Figs. 9 to 10. Special note: 12 \times , 15 \times , 20 \times , 100 \times , and 500 \times refer to magnification.

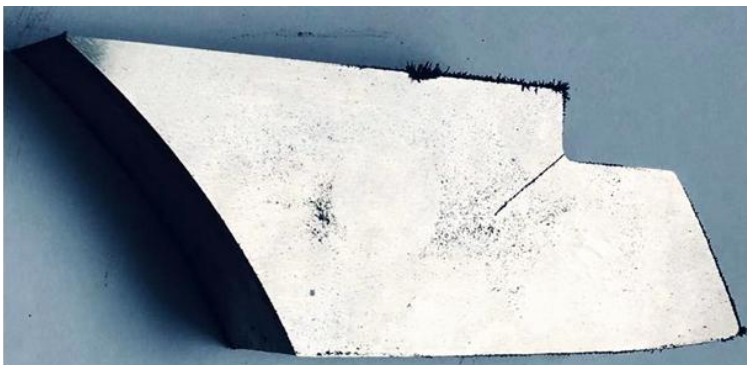
Figure 11: Cracks that occur at the transition R position on the other side.

As the fracture originated at the transition R position of the connecting rod screw installation surface, to comprehensively assess the structural integrity of the connecting rod cover, the other side transition R of this connecting rod cover was dissected, and its dimensions were inspected. After dissection, it was found that a crack about 16 mm deep also appeared at this transition R position, starting from the transition R and extending inward, as shown in Fig. 11.

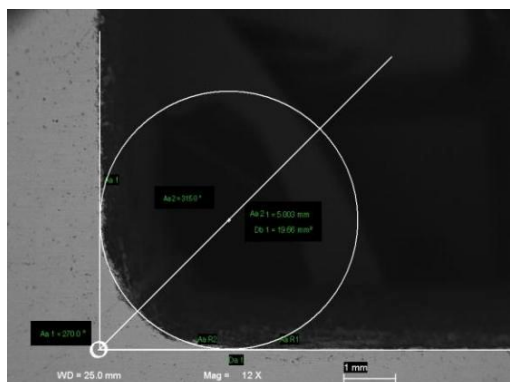
Figure 12: Transition R size (12×).

Furthermore, a dimensional inspection of the transition R was carried out to provide parameters for subsequent dimensional optimization. The magnification used was 12× and 15×. After inspection, the size of the transition R was approximately 2.50 mm, as shown in Figs. 12 and 13.

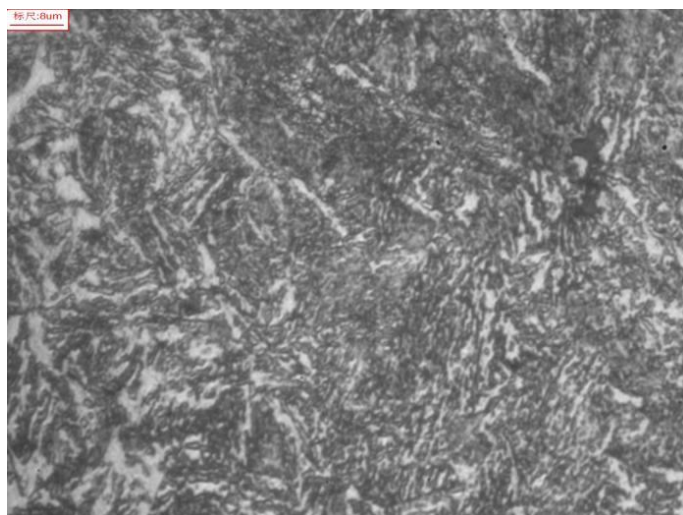
Figure 14: Metallographic structure (500×).

Near the fracture surface of the connecting rod cover, samples were extracted using the standard metallographic sampling method and detailed microstructure observation was conducted with a metallographic microscope at a magnification of 500×. The inspection results showed that the microstructure near the fracture was tempered upper bainite, with no inclusions or abnormal deformations found. This is in line with the material heat treatment specifications, indicating a normal microstructure state and no typical material defects [18]. For specific details, please refer to Fig. 14.

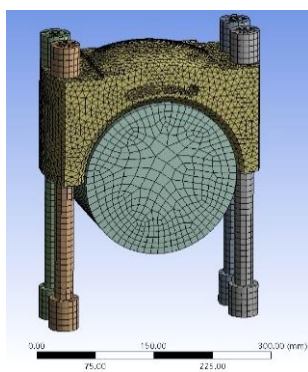
Figure 16: Mesh generation.

Meshing settings, constraint and load: The simplified model was meshed. The bolt and crankshaft simplified models were set to the Hex Dominant method, with the maximum limit of related elements within 8 m units. The final meshing resulted in 20,571 nodes and 55,439 elements, as shown in Fig. 16. Constraints were applied to the four bolts and the simplified model, and a rotational speed of 14,400 mm/s was applied to the simplified rigid body according to the compressor's working mode. This rotational speed is much higher than the actual working condition because the research object is a commercial product, and the relevant working conditions are not directly provided. A higher rotational speed also means a higher optimization standard. The relevant settings are shown in Fig. 17.

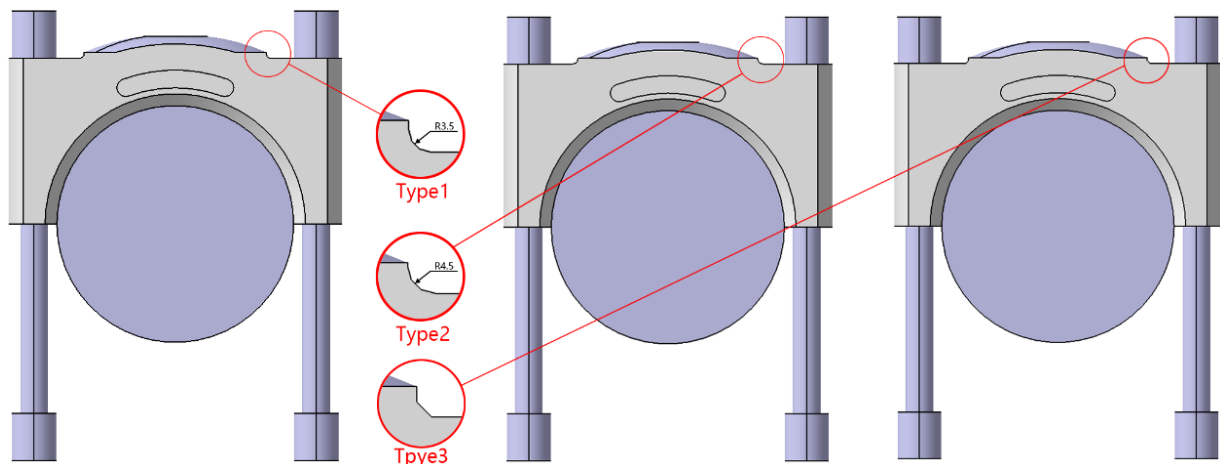
Figure 19: Structural optimization scheme.

Based on the part inspection and simulation results, it can be inferred that there is stress concentration in the transition area of the connecting rod cover's bolt installation surface, which leads to the fatigue fracture of the workpiece. Therefore, during the optimization of the part design, this area was optimized. The first optimization scheme increased the fillet radius of the transition area from the original R2.5 to R3.5 and R4.5 respectively; the second

optimization scheme changed the fillet of the transition area to a chamfer, as shown in Fig. 19. The finite element meshing and boundary condition settings for both types of optimization were consistent with the original structure simulation.

Through simulation, it is found that the larger the fillet radius, the more effectively the stress concentration can be improved, and the risk of fatigue fracture can be reduced. However, when it increases to a certain extent, the improvement effect will decrease. A reasonable fillet radius can be selected according to the design. The chamfer structure can reduce the degree of stress concentration, but it cannot completely solve the problem of stress concentration. Under long-term use, fatigue fractures can still occur.

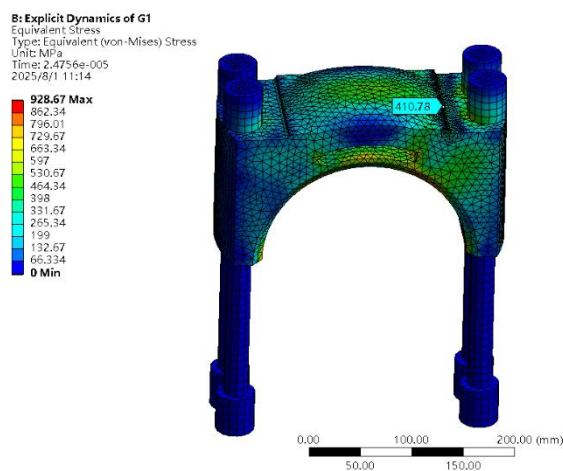
Figure 20: R3.5 simulation.

The simulation of the R3.5 type structure of the first optimization scheme is shown in Fig. 20. Compared with the original structure, no fracture failure occurred in the transition zone of the cover bolt connection platform, and the stress at this location was around 410 MPa. The stress concentration was significantly improved, effectively reducing the risk of fatigue fracture of the workpiece due to stress concentration.

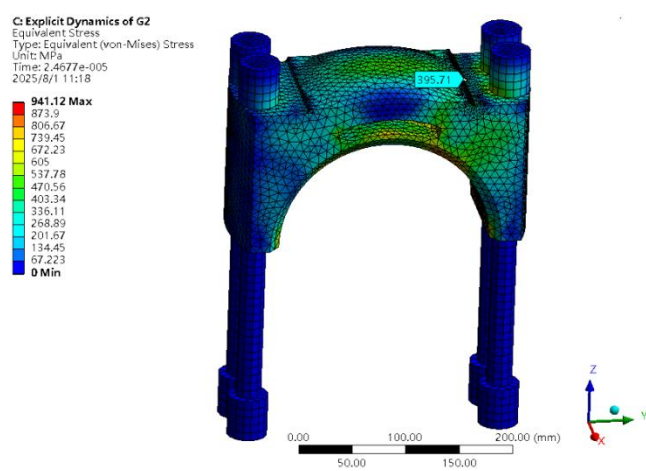
Figure 21: R4.5 simulation.

Further simulation was conducted on the R4.5 type structure, and the results are shown in Fig. 21. Compared with the original structure, no fracture failure occurred in the optimized scheme 2 either. The stress in the transition area of the cover bolt connection plane was further reduced compared with the R3.5 type structure, around 395 MPa, and the stress concentration was further improved. However, the reduction amplitude was slightly weaker than the improvement effect of the R3.5 structure and the original structure.

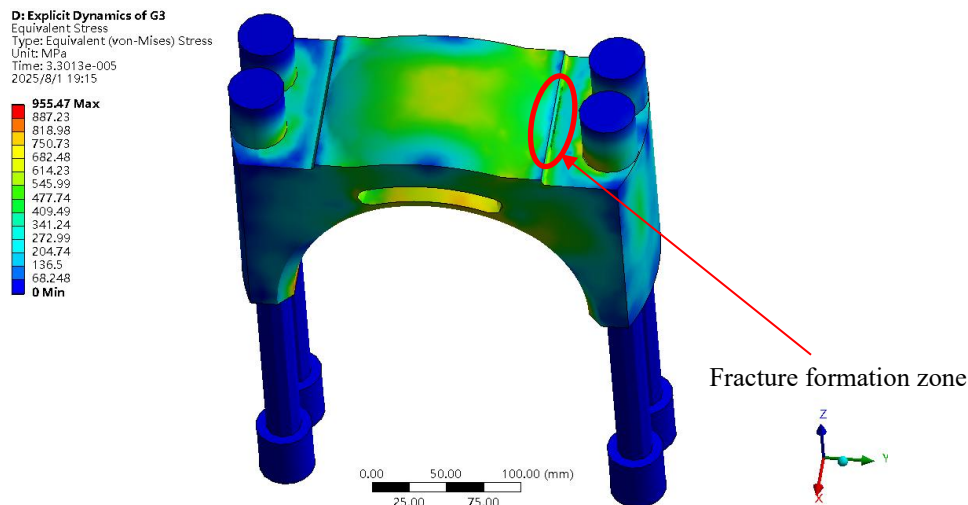
Figure 22: Stress distribution of chamfered structures.

After replacing the fillet transition structure with the chamfer structure and conducting the simulation again, the results are shown in Fig. 22. Compared with the original structure, although no failure or fracture occurred in this optimized scheme, a fracture crack area still appeared in the transition zone of the cover bolt connection plane. Compared with the fillet

type structure, this kind of structure also has a stress concentration area. Under long-term operation, the parts still have the risk of fracture failure.
